# ADA TRANSITION PLAN (*DRAFT*)

## **RIGHT OF WAY AND FACILITIES**

Adams County

# APPENDIX D – FACILITIES DEFICIENCY EXHIBITS

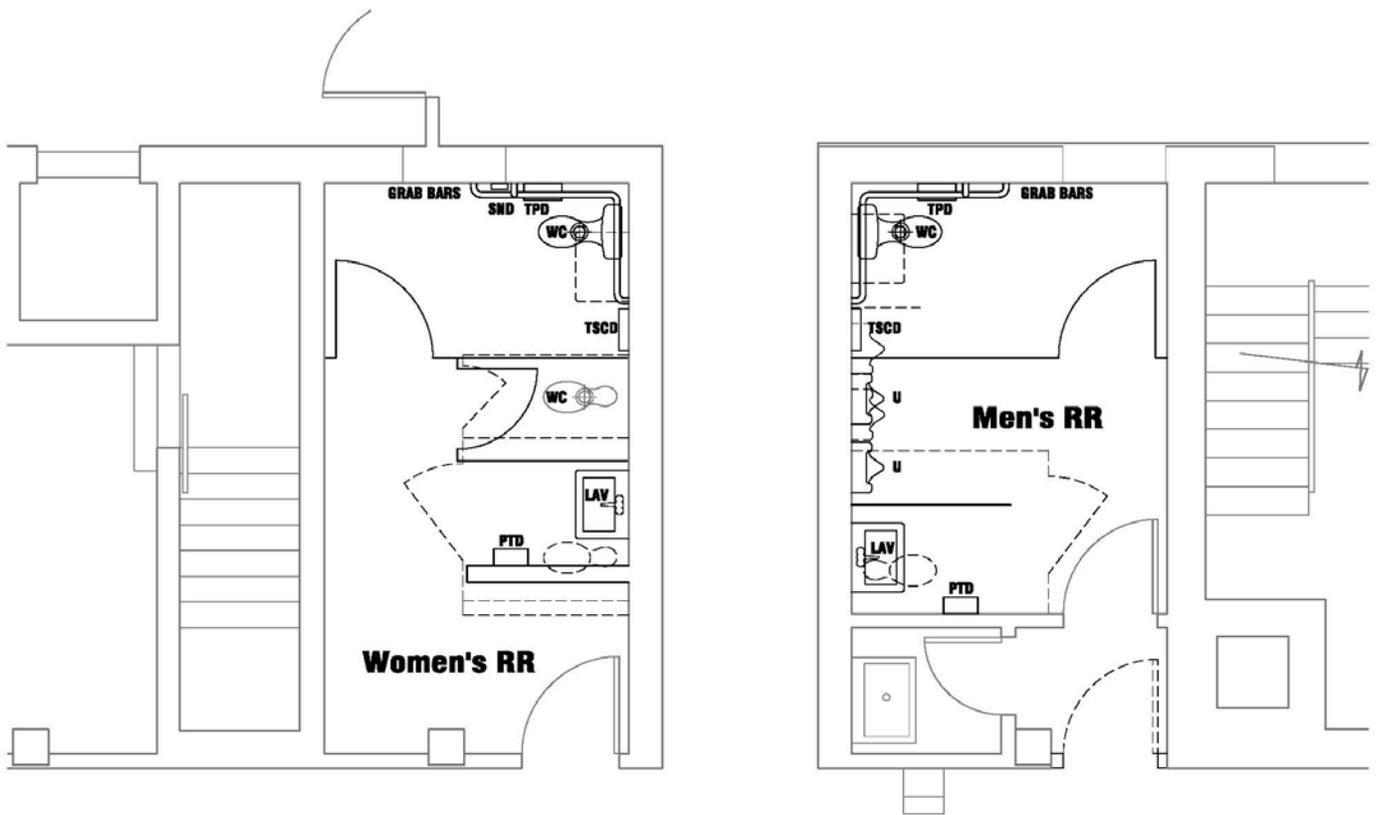
ADAMS COUNTY COURTHOUSE (Continued)

**Adams County**  
**COURTHOUSE - ADA Compliance**  
DOH 1505 6/16/15

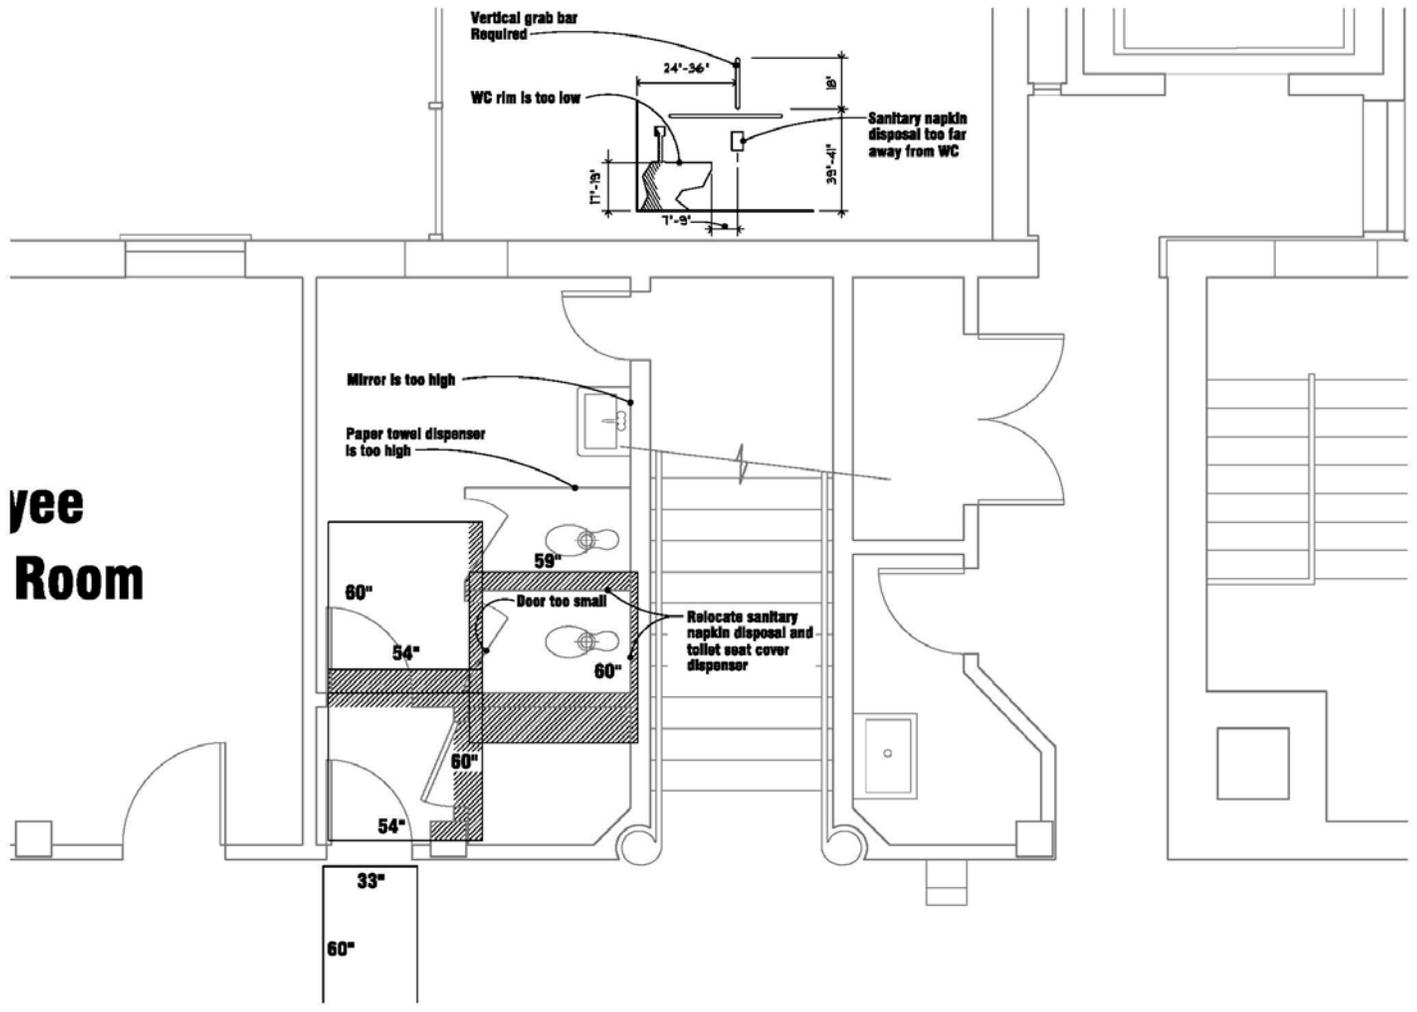
ADAMS COUNTY COURTHOUSE (Continued)

**Adams County**  
**COURTHOUSE - ADA Compliance**  
DOH 1505 6/18/15

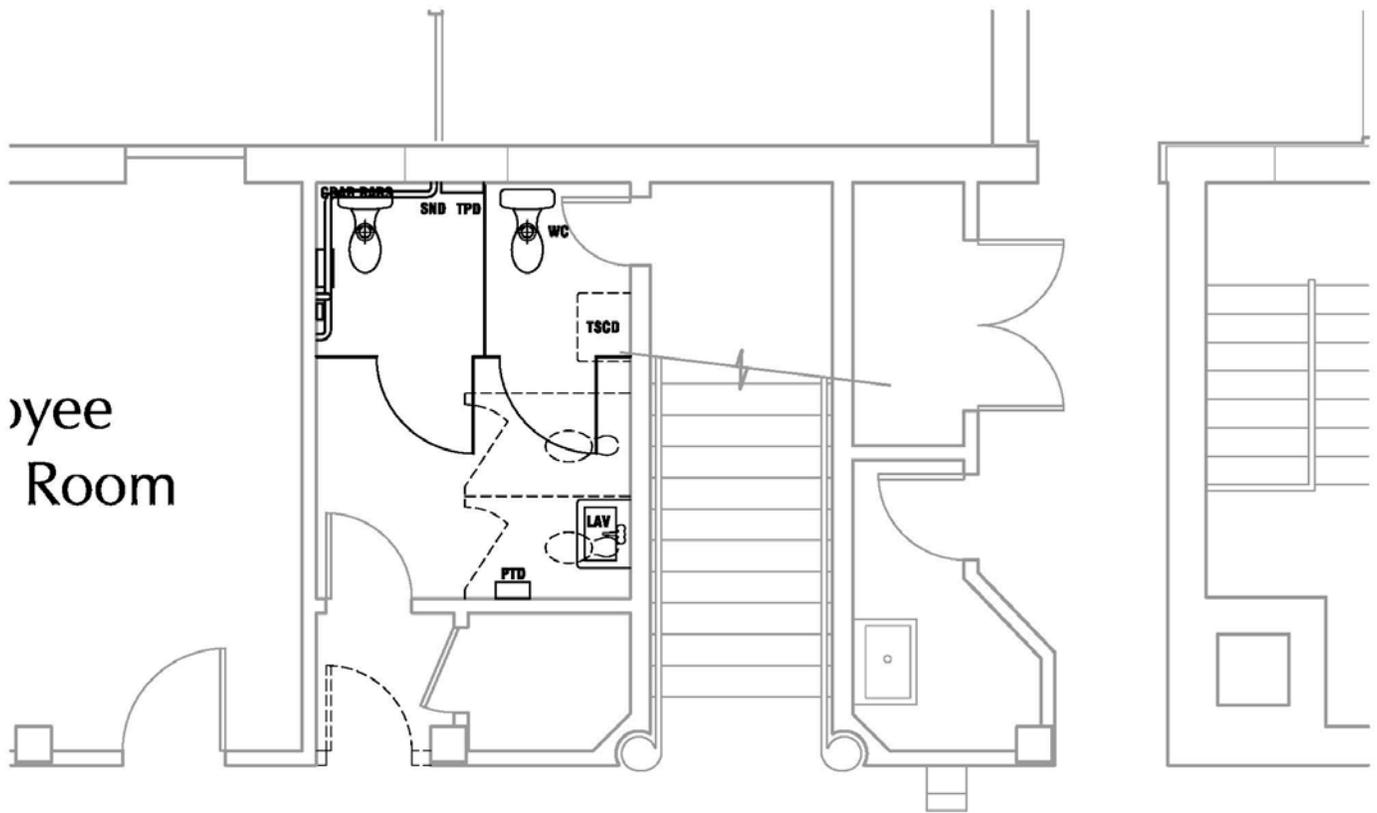
ADAMS COUNTY COURTHOUSE (Continued)

**Adams County**  
**COURTHOUSE - ADA Compliance**  
DOH 1505 6/16/15

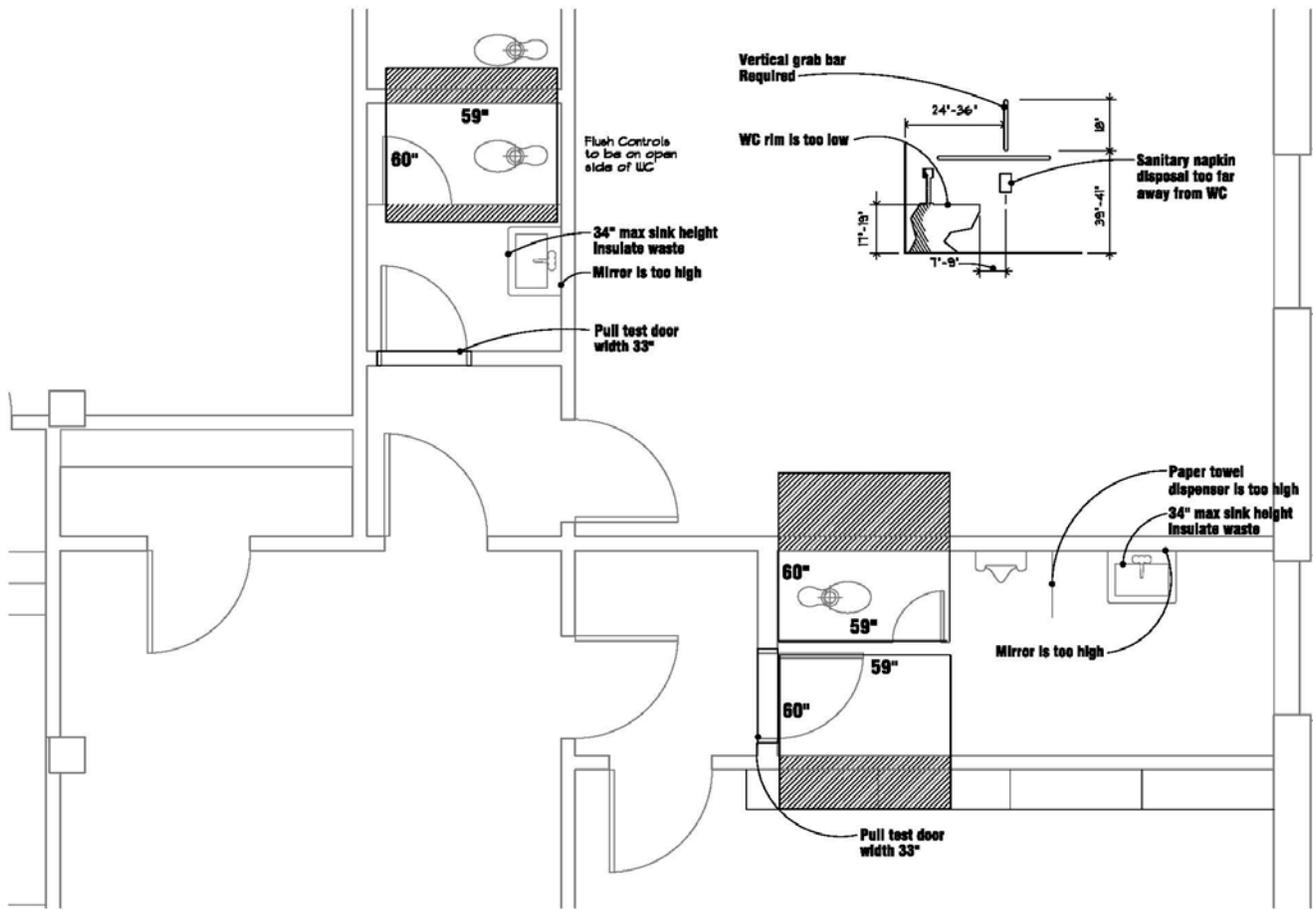
ADAMS COUNTY COURTHOUSE (Continued)

**Adams County**  
**COURTHOUSE - ADA Compliance**  
DOH 1505 6/18/15
